THE NAVAL AVIATION SAFETY REVIEW

approach

VOLUME 5 NUMBER 2

Published by U.S. Naval Aviation Safety Center
NAS, Norfolk 11, Va.

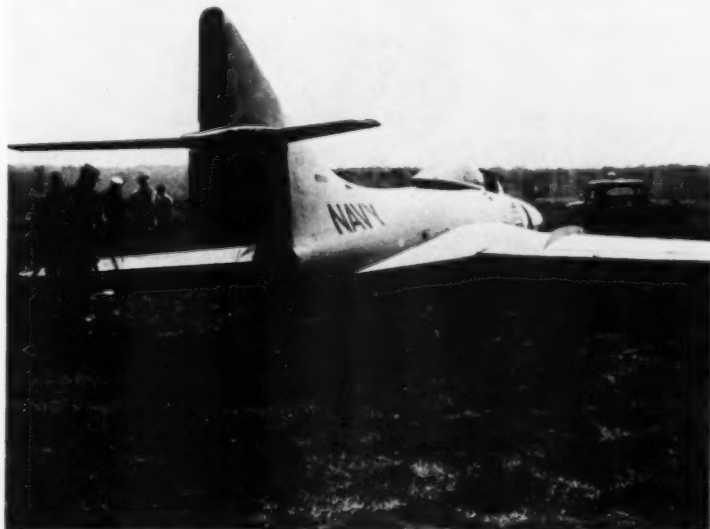
Photos added weight to the opinion that the takeoff was attempted with flaps up.

In examining the plane immediately after the accident the board found both the wing flaps and the flap handle in the cockpit UP. The flaps were virtually undamaged in the crash and it was concluded they were not forced into the UP position due to impact with the ground. It was considered unlikely that the flap handle was inadvertently jostled to the UP position during the course of the takeoff because of the positive inboard movement required to release the handle from the down detent. The plane captain who observed the pre-taxi checks reported that the flaps were up when the airplane departed from the line.

Considering this information the board concluded that the pilot made the entire takeoff attempt with the flaps up. As a final phase of the investigation the board reviewed F9F-6 aerodynamic data. Takeoff distance for the existing conditions with

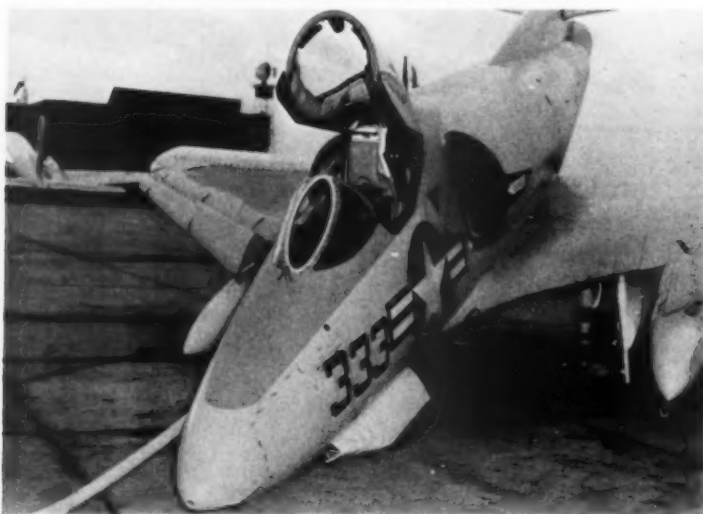
The gear handle was not down when starting power was applied.

"After inspecting the aircraft externally," said the pilot, "I manned the cockpit. After strapping in I asked for starting power. The time was approximately 0555. As soon as I came around the horn for start, the nose gear commenced to collapse. I immediately reached for the gear handle and put it to the DOWN position.

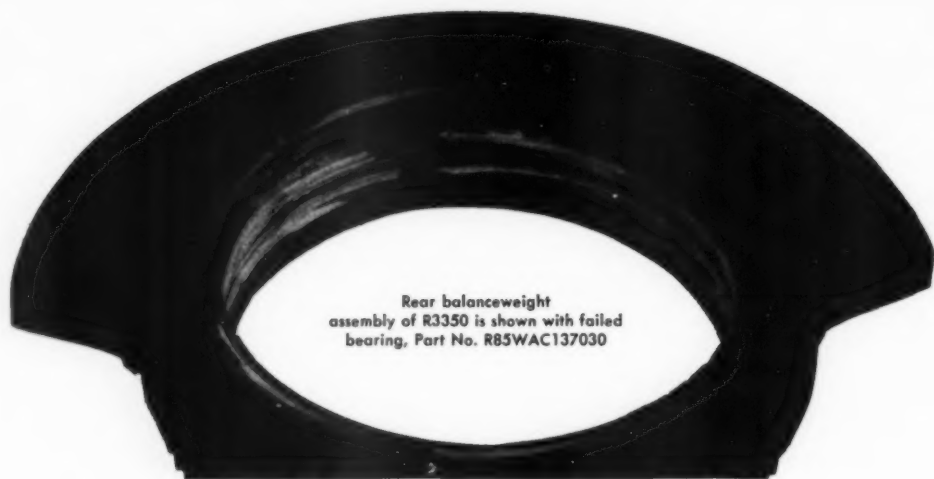
Rear balanceweight assembly of R3350 is shown with failed bearing, Part No. R85WAC137030

Failure of the front and rear second order counter balance bearings are a leading cause of premature R3350-26WB engine failures due to metal contamination. These bearing failures, for the most part, are caused by lack of lubrication. This condition in turn is attributable to (1) Failure to properly and thoroughly pre-oil the engine subsequent to initial installation and, (2) due to momentary oil starvation during actual engine operation.
